AFRPL-TR-77-39

6  
2  
3  
4  
5  
10  
**A MICROPHOTOGRAPHIC STUDY  
OF AN EPOXY BOND SYSTEM FOR  
SEMICONDUCTOR STRESS  
TRANSDUCERS.**

11  
**AUGUST 1977**

9  
**SPECIAL REPORT**

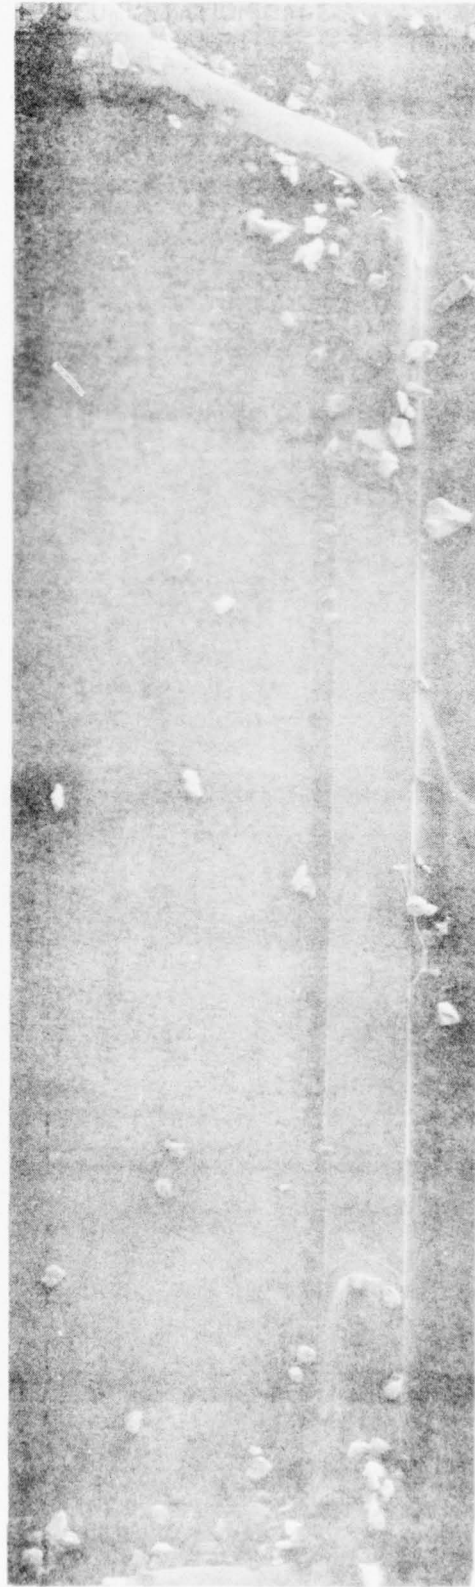
Figure 3. Composite Picture of One Bonded Silicon Strain Gage with Gold Lead Attachment (160X)

Initially, a composite picture of the epoxy bonded silicon gage specimen at 160X magnification was obtained and is shown in Figure 3. It is evident from this figure that there was an epoxy fillet on each side of the gage as expected. It is also evident and somewhat surprising that numerous dust particles were scattered on and near the gage. To investigate these strange dust particles and the epoxy fillet configuration further, higher magnification photographs ranging from 480X to 5,000X were taken at various angles and localities of the specimen as shown in Figures 4 through 13. From these figures, it appeared that the dust particles were loose and were not partially imbedded in the epoxy coated metal surface. This appearance was later confirmed as the particles were readily removed by using a freon jet. All of these photographs show that the height of the epoxy fillet along the sides of the gage varied considerably. This variation appears more pronouncedly at the higher magnifications as shown in Figures 11 and 13. Epoxy filler particles are also observable in the higher magnification photographs. In Figures 8, 9, and 10, the texture of the metal (17-4 stainless) surface is clearly visible. In comparing the metal texture with the sizes of the epoxy filler particles, the metal surface appeared to be relatively smooth.

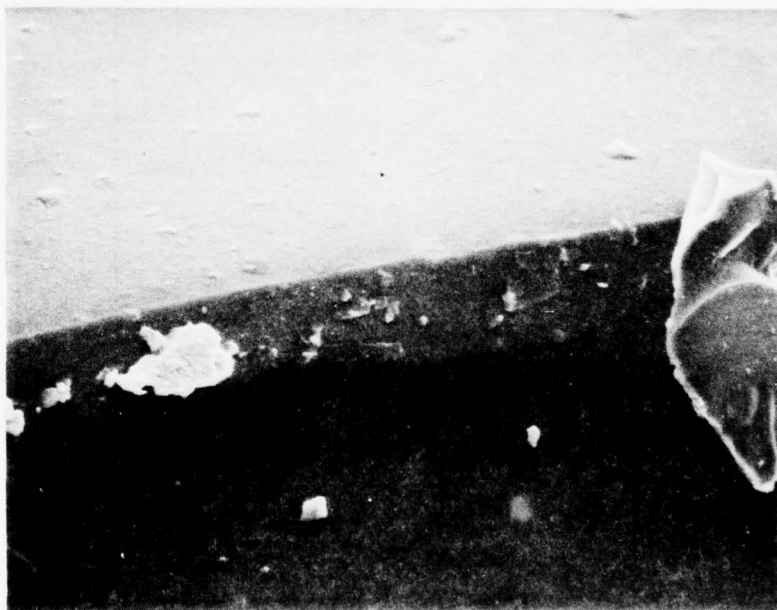
Figure 7. Side of Bonded Silicon Gage (2, 200X)

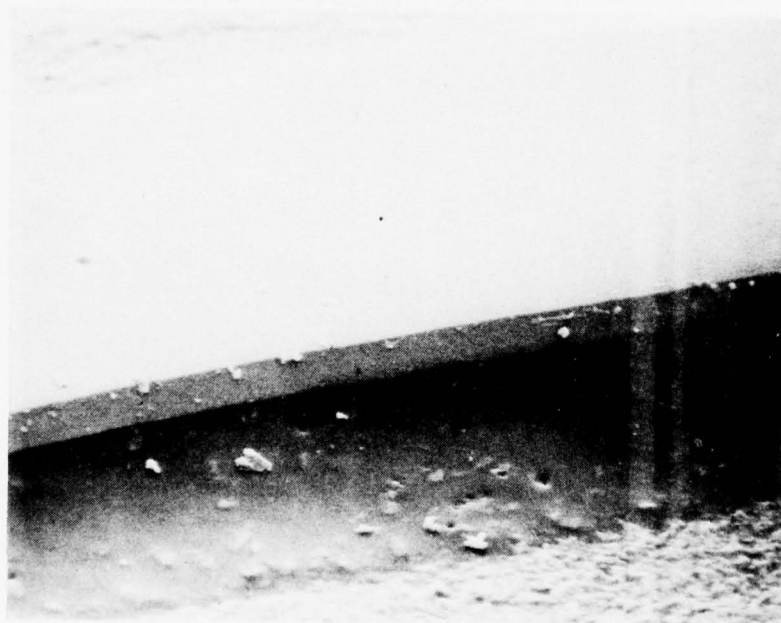
Figure 9. Side of Bonded Silicon Gage (650X)

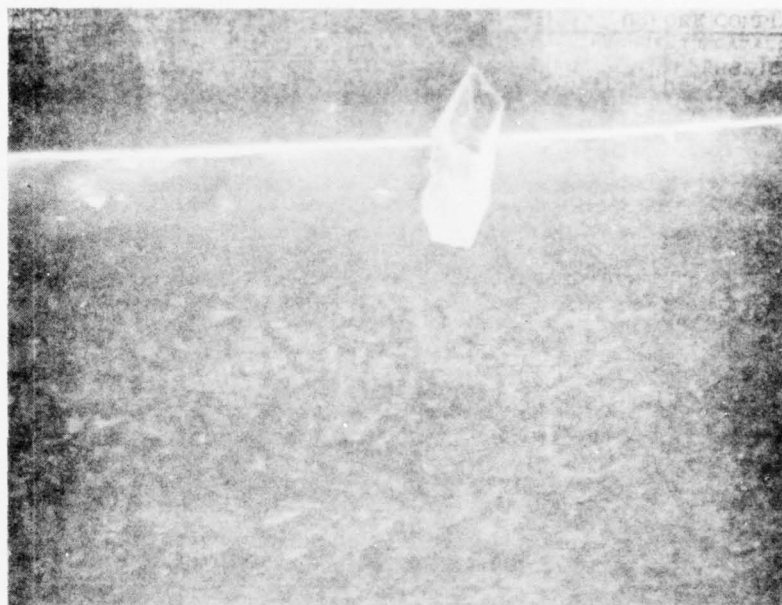
Figure 10. Side Edge of Bonded Silicon Gage (1,200X)

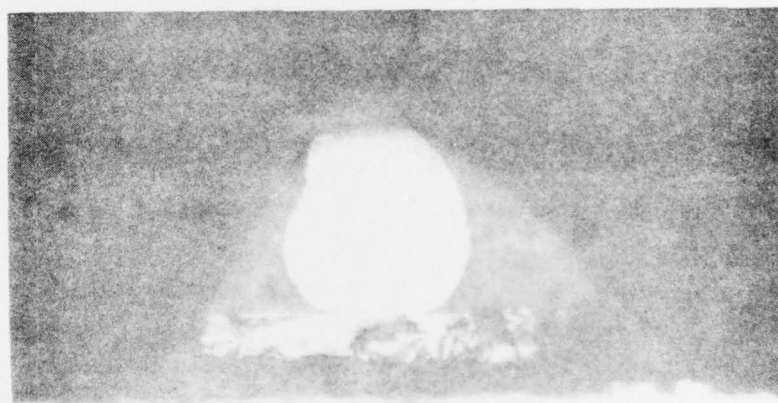
Figure 19. Specimen Cross-Section 2 (500X)

Photographs of the ten gage cross-sections investigated are shown in Figure 18 through 27. The location of each cross-section can be readily identified from Figure 2. The dimensions of these photographs were calibrated by photographing a grid with 0.001 inches spacing as shown in Figure 28. In Figures 18 and 19, the metal base, the epoxy adhesive layer, the silicon gage, the gold leadwire and the epoxy wire cover are all clearly visible. It is interesting to note that the gold wire was not in good contact with the gage at cross-section 1; good contact was evident in cross-section 2, however. In Figures 20 through 25, only the metal base, the gage and the epoxy adhesive layer are shown. In Figure 26, the gold leadwire at the other end of the gage is also shown. Figure 27 shows that only some epoxy and the metal base remained after the gage and the gold leadwire had been ground away. From the gage cross-sectional photographs, the epoxy adhesive layer thickness, the gage thickness, and the gage width were measured. The measurements obtained were tabulated and is presented in Table 1. The epoxy and the gage thickness were measured at three points in each cross-section-left side, center, and right side. The gage width was

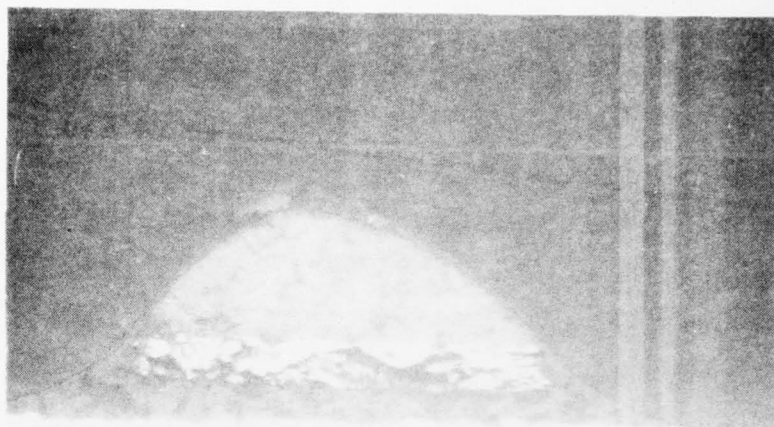
Figure 20. Specimen Cross-Section 3 (500X)

Other results of interest are that the gage cross-section was found to be of a slight trapezoidal shape with the bottom surface slightly curved upward (bow shaped). These can be readily detected from Figures 20 through 26. It can also

be seen from these figures that the height of the epoxy fillets along the two sides of the gage were uneven. It is very apparent that the fillet on the right side was much higher. This variation, along with the results presented earlier that the gage was slanted downward to the right, tend to infer that the gage was placed on the epoxy layer with higher pressure applied to the right side.

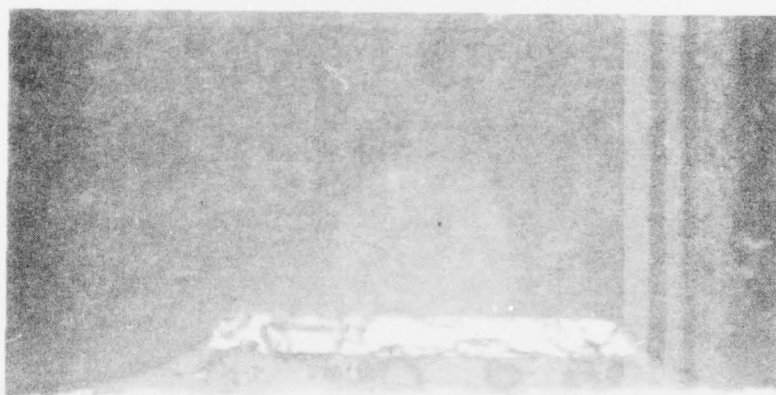
Figure 21. Specimen Cross-Section 4 (500X)

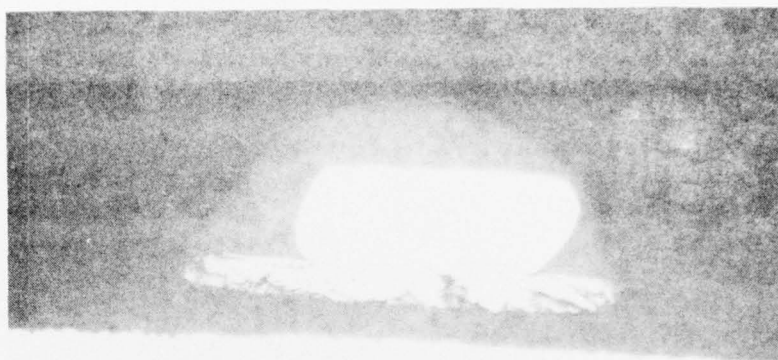
Figure 26. Specimen Cross-Section 9 (500X)
